# AIR SERVICE INFORMATION CIRCULAR

No. 365

## STATIC TEST OF THE AEROMARINE PG-1 AIRPLANE

Prepared by E. R. Weaver  
Engineering Division, Air Service  
McCook Field, Dayton, Ohio  
April 20, 1922

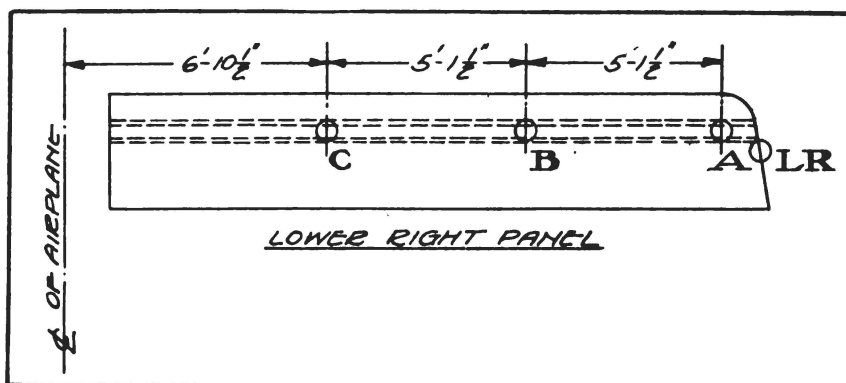
FIG. 7.—Table of spar deflections

The required load factor for a reverse flight test on wings of an airplane of this type is 3. The wings supported a load factor of 3 without any failure.

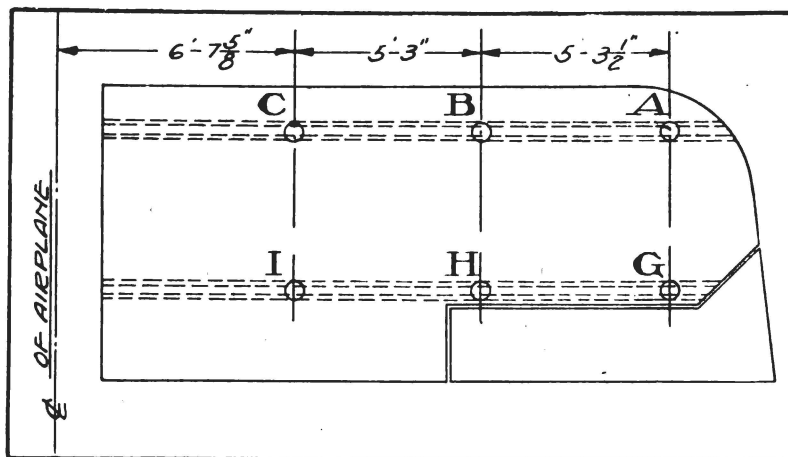
FIG. 10.—Table of spar deflections.

No failures occurred during this test, but the lower wing tilted backward and downward on the strut fittings and deflected badly while supporting a load factor of 3.5. The wing structure supported the required load factor of 4.5.

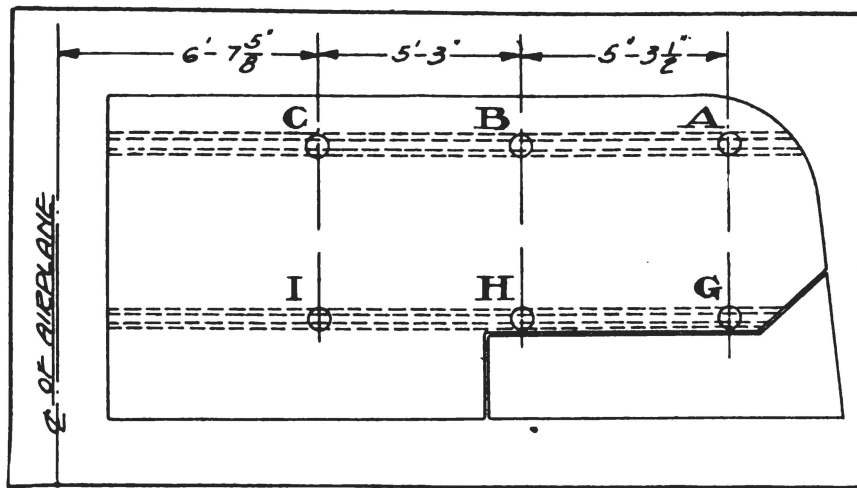
FIG. 13.—Table of spar deflections.

The right upper front strut fitting failed in bending while the structure was supporting a load factor of 6.5.

NOTE.—At a load factor of 5 the upper spar center section compression tube deflected  $\frac{1}{4}$ " at A. L. F. of 6 the tube deflected  $\frac{1}{2}$ " and had to be reinforced with wood members to prevent failure.

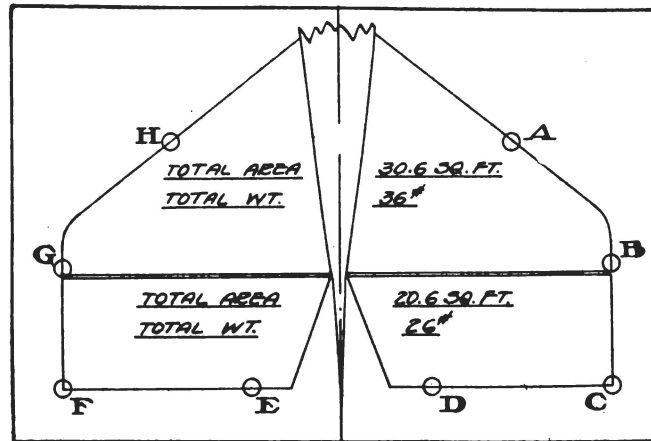
FIG. 21.—Loading schedule and results of test.

The first failure was the buckling of the rear spar of the stabilizer at a load of 20 pounds per square foot. The right side collapsed. The test was continued on the left side of stabilizer and at 27.5 pounds per square foot failure occurred.

First failure at loading of 20 pounds per square foot right rear stabilizer spar buckled between first and second rib from fuselage.

Second failure at loading of 27.5 pounds per square foot left rear stabilizer spar.

Redesign stabilizer rear spar to eliminate failure in bending.

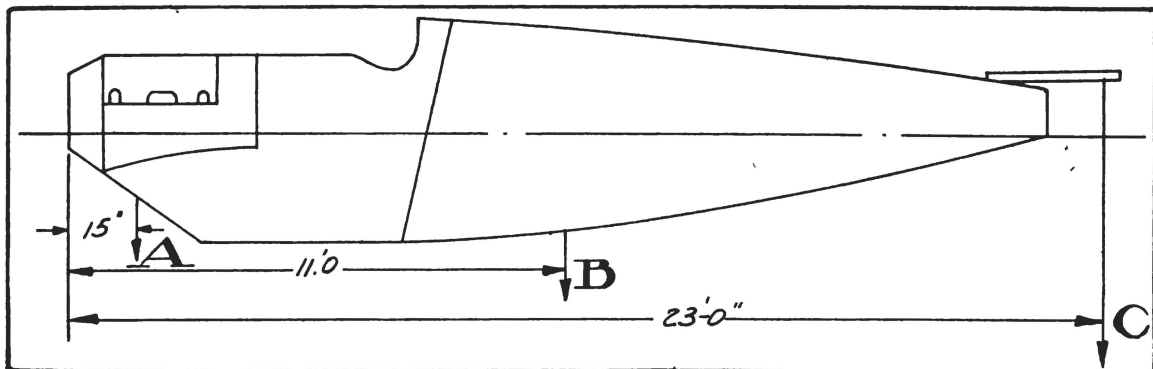
The deflections and results are shown in Figure 29. The required load factor was 6. The structure supported a load factor of 6.5 and then failed in first bay to rear of the armor plate. The lower longerons failed in compression.

The first failure was the left lower longeron, which failed when the fabric was cut. The tube was drawn back to place by blocks and clamps and a load factor of 7 was imposed. The fabric on the right side was then cut and failure of right longeron followed.

Load factor.	Deflections at—			Remarks.
	A	B	C	
2	0	.2	.7	
3	0	.3	1.0	
4	-.1	.3	1.1	
5	-.1	.4	1.6	
5.5	-.1	.4	1.8	
6	-.2	.5	2.0	
6.5				Failure of left lower longeron after fabric was cut, this longeron was reinforced and right lower longeron failed a factor of 7.
7

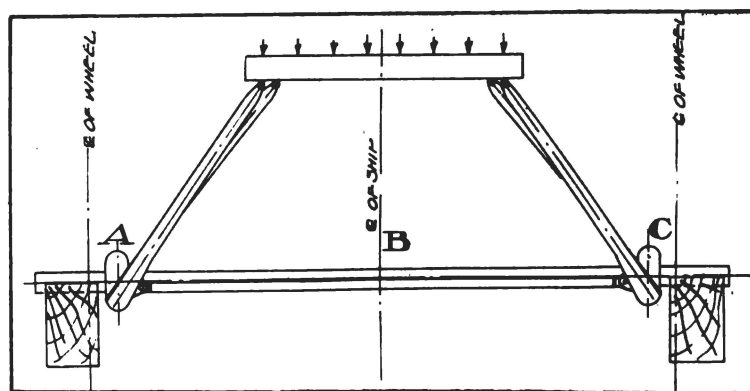
FIG. 30.—Loading schedule and deflections for landing chassis.

The right shock absorber fitting failed at a load factor of 5. The two five-sixteenths bolts sheared off while the center three-eighths inch bolt on the lower side pulled entirely through the fitting.

Load factor.	Deflections at—			Load in pounds, factor.	Total load (pounds).	Remarks.
	A	B	C			
2	1 1/8"	1 1/8"	1 1/8"	6,641	6,641	Shock absorber chords removed. Held.
3	1 1/8"	1 1/8"	1 1/8"	3,918	10,559	
4	1 1/8"	1 1/8"	1 1/8"	3,918	14,447	
4.5	1,959	1,959	1,959	1,959	16,436	Struts on right-hand side sinking into fitting, strut deflecting, axle 1/8" set. Failure of 1/8" bolts on right-hand side.
5	1,959	1,959	1,959	1,959	18,395	
5.5	1,959	1,959	1,959	1,959	1,959	Required factor.
6	1,959	1,959	1,959	1,959	1,959

Strengthen the shock-absorber fittings where failures occurred. These fittings should be redesigned to stand a load factor of 6, the required factor for the struts.

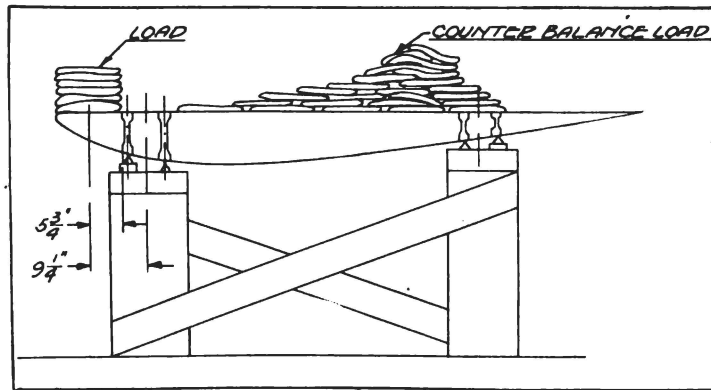
Since the failure occurred at a load factor of 16.3, the leading edge is amply strong.

The leading edge was loaded in accordance with the above sketch.  
 The load was increased until the total load on the leading edge was 3,450 pounds.  
 The structure supported this load for one minute when the failure occurred.  
 The leading edge sheared off at the face of the front spar.  
 Load for factor of 1 = 3,308 pounds load carried by upper wing  $3,308 \times .7 = 2,315.6$  pounds.  
 Load per foot run =  $2,315.6 \div 32,875 = 70.43$  pounds.  
 Load for factor of 1 on leading edge =  $70.43 \div 2 = 35.21$  pounds.  
 Load on leading edge causing failure = 3,450 pounds.  
 $3,450 \div 6 = 575$  pounds = load per foot run causing failure.  
 $\frac{575}{35.21} = 16.32$  factor at which leading edge failed.
